INCLINOMETER FAILURE

TA 18-119

Crane family: GMA

Model: 32/27 - 40/30

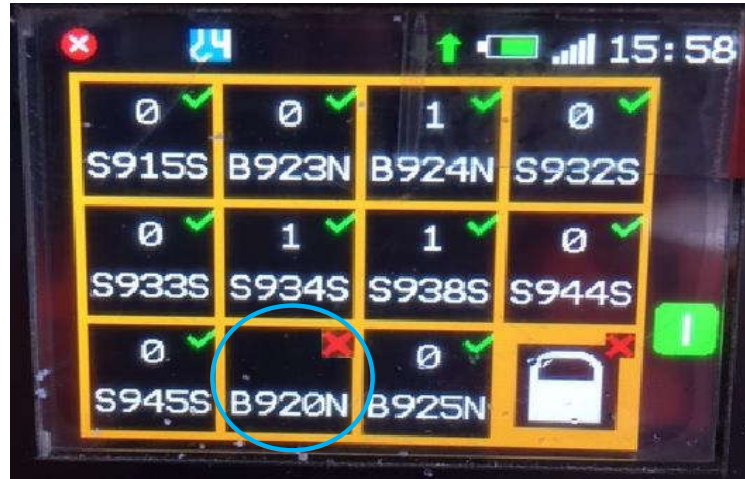
Inclinometer failure code: 84016669

When the inclinometer is out of service (red X on the B920N in the status of contacts) it's impossible to dismantle the crane in normal mode, only the mode shunt allows it (very dangerous).

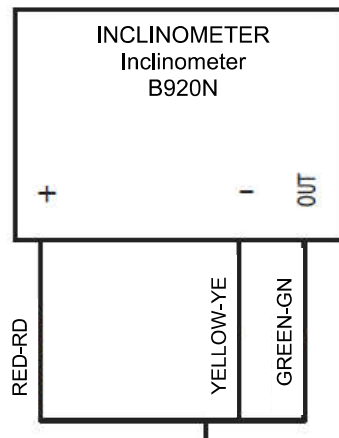
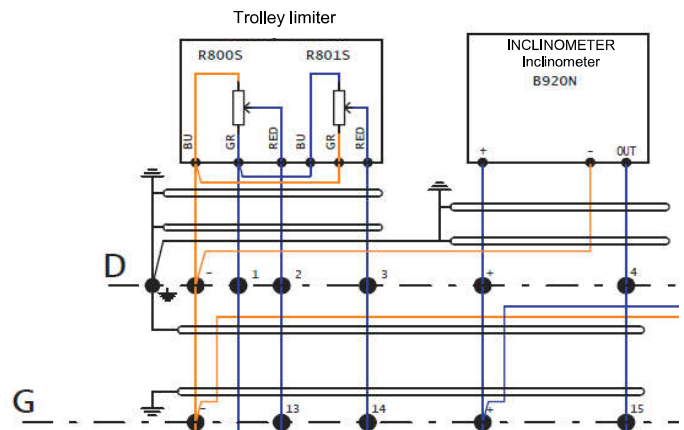
Inclinometer failure code: 84016669

When the inclinometer is out of service (red X on the B920N in the status of contacts) it's impossible to dismantle the crane in normal mode, only the mode shunt allows it (very dangerous).
