FCAN CARD IMMUNITY ON ACS380

TA21-312-C

Product Improvement Program (PIP) :		Service bulletin :		Instructions :	
Crane family : GMA		Range : HUP		Model : HUP40/30 and 32/27	
C	Technical Support	July 30th, 2021	Code change 84115199, page 6		
B	Technical Support	July 1st, 2021	Modification		
A	Technical Support	June 24th, 2021	Creation		
Index	Written by	Date	Comment

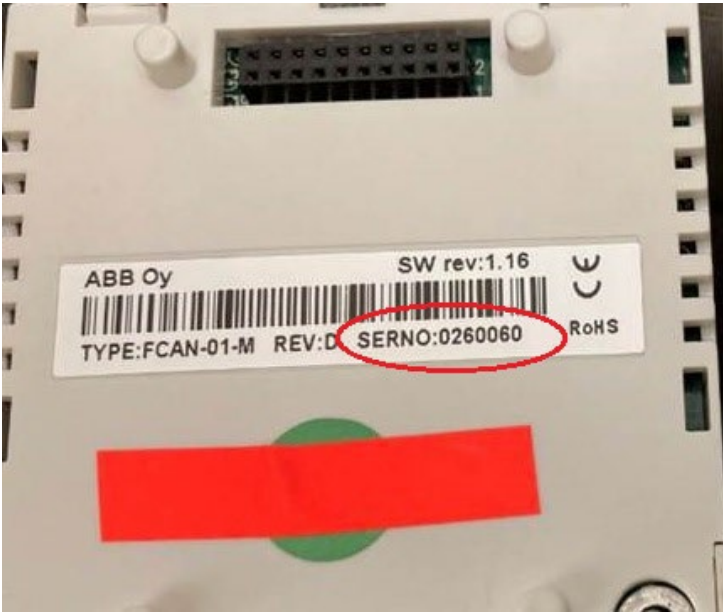
DIAGNOSIS	<p>The slewing ACS380 drive stops during a deceleration phase of the slewing motion, the drive indicates a 5091 status (CAUTION, this status is not always due to a CAN card fault). EMC disturbances corrupt the exchange between the CAN card and its drive. In this case the ACS380 drive stops. This fault can be identified by losses in the steering converter device only.</p>
SOLUTION	<p>To this date, we have identified that the more sensitive FCAN-01-M ACS380 cards have a serial number starting with 026:</p> <div style="text-align: center;">
